CASE STUDY

Short Range Ultrasonic Technique (SRUT)

Online Tank Annular plate Ring Inspection

(Egyptian LNG, Egypt)

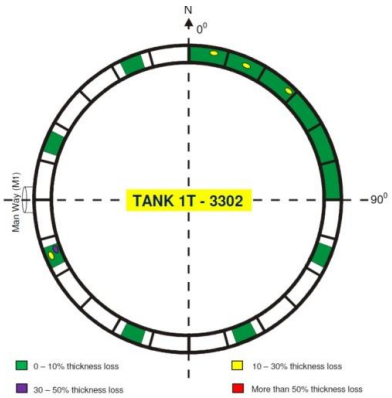
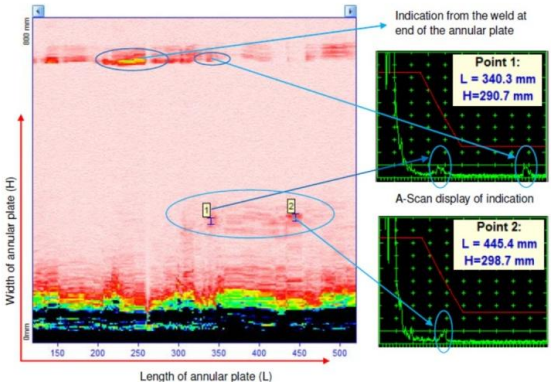
During the inspection most of the annular plates rings were found to have no major corrosion. Five minor corrosion indications and one moderate indication were observed in two annular plate rings.
